TEST REPORT

No. : XMIN1502000773ML

Sample Name : INTER CLAMP
Product Specification : 40
Manufacturer : Xiamen Solar First Energy Technology Co.,Ltd
Buyer : Xiamen Solar First Energy Technology Co.,Ltd
Material and Mark : AL6005-T5
Other Information : SF-IC-40
Date of Receipt : Feb 05, 2015
Testing Start Date : Feb 05, 2015
Testing End Date : Feb 12, 2015
Test result(s) : For further details, please refer to the following page(s)

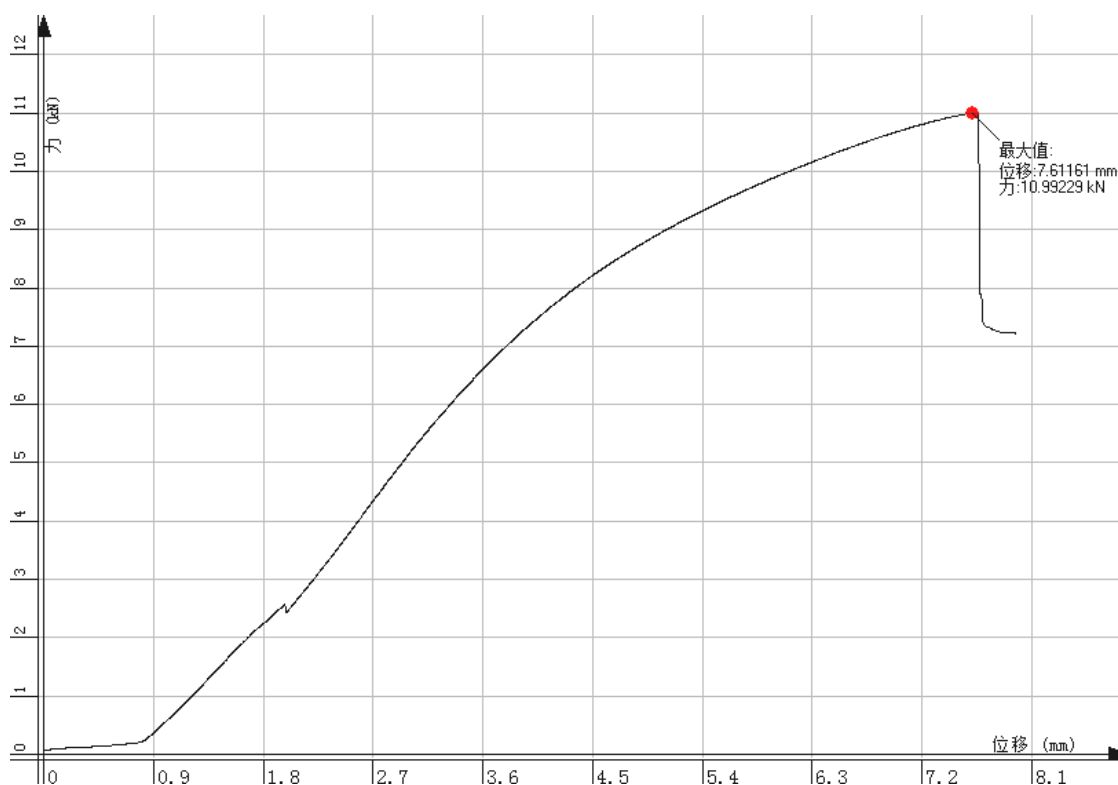
Test result: the maximum pull force was 10.99kN

Force-displace curve

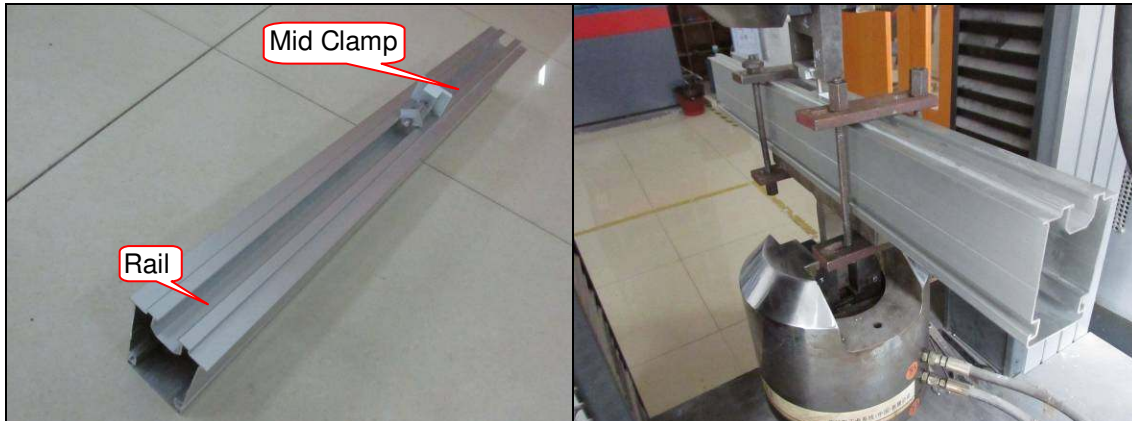
Photo 1: the assemble parts

Photo 2: test method

Test method: according to the client's requirements, fixed the assembly on the test machine as photo2 and photo3, then load force by 5mm/min till damaged. Determine the maximum force.

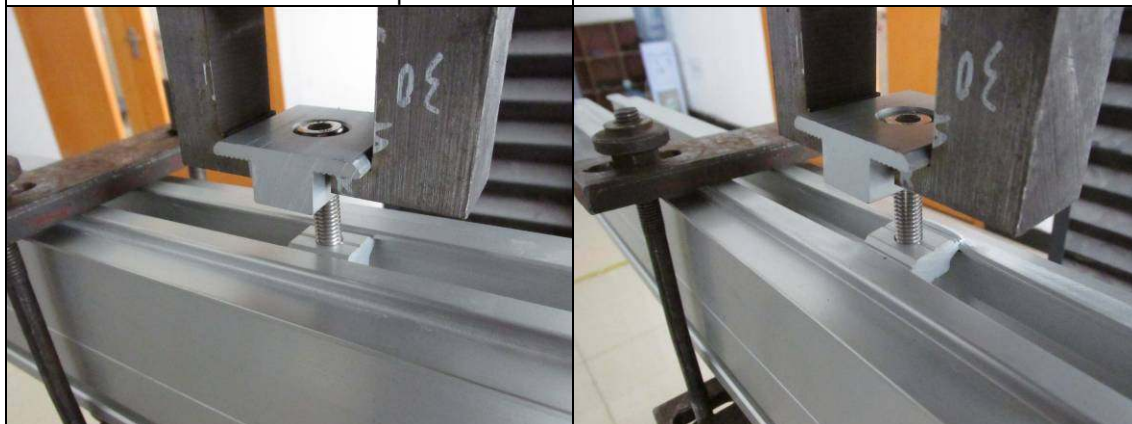
Photo 3: before load

Photo 4: the moment of fracture
